# Case study: Temple of Preah Vihear, Cambodia

Asia-Pacific Dialogue on Heritage and Authenticity  
Ha Nội and Ninh Binh · 27 September–1 October 2026

# Myanmar's Experience of Heritage Recovery

Bagan after the 2016 Earthquake and  
Mandalay after the March 2025 Earthquake

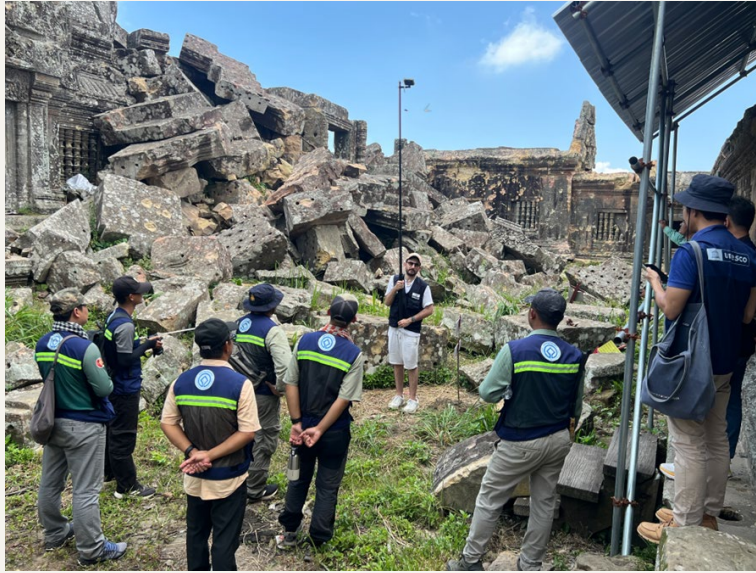
# 3D documentation preserves spatial evidence

- 1 Establish durable survey control
- 2 Capture overlapping images and scans
- 3 Check accuracy and link damage records
- 4 Archive usable data and train NAPV staff

**Document successive clearance stages  
when fragment positions change.**

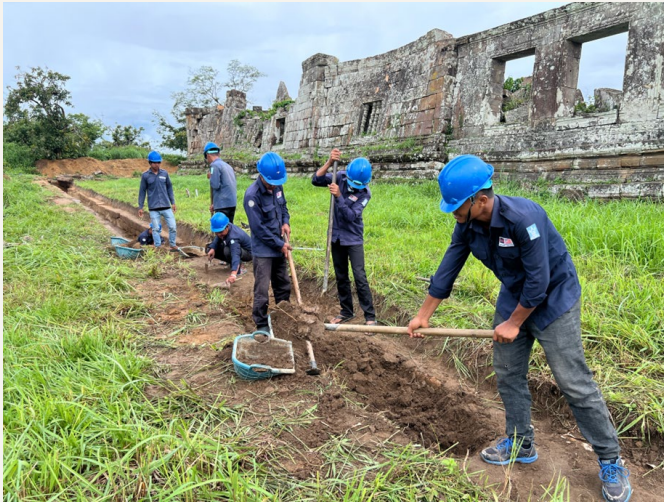
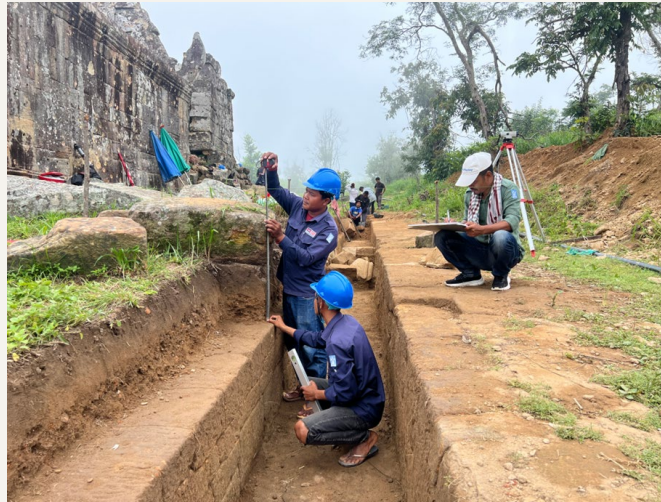
# Ancient hydraulic system rehabilitation between Gopura 3 and Gopura 4

- 1 Map catchments, terrain and water flows
- 2 Survey historic channels and outlets
- 3 Record, clear and repair with archaeological oversight
- 4 Test during rain; monitor platform stability

**Water management supports structural stability.**

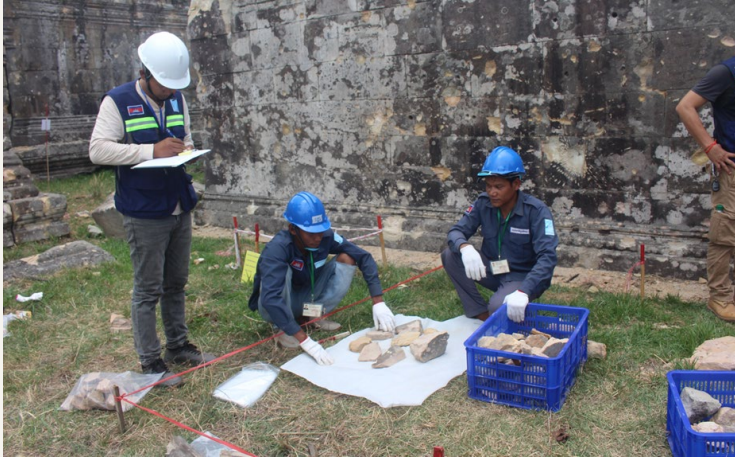
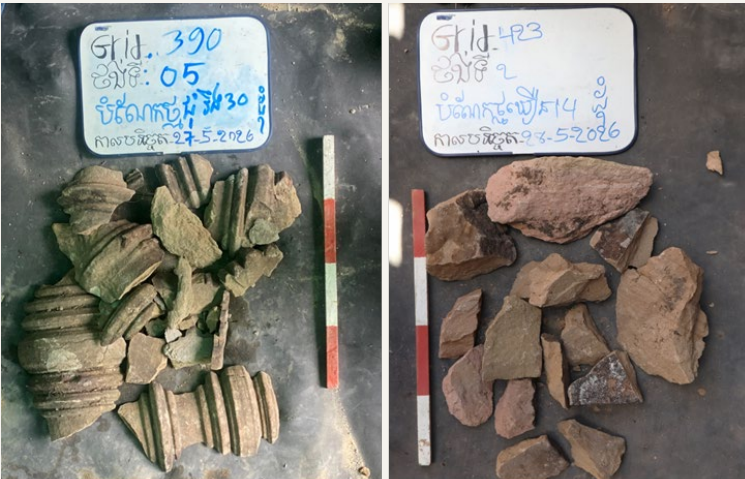
# Documentation and Safeguarding of scattered stone fragments

- 1 Record find position before movement
- 2 Assign an ID, photograph and assess condition
- 3 Move under supervision; protect fragile pieces in situ
- 4 Store securely under shelter; retain links to records

**29,186 carved fragments  
and 36,552 plain fragments.**
